# Play Area / Equipment Operational Inspection

TWT PARK PLAY AREA

| Audit Title | TWT PARK PLAY AREA |

| Client / Site | COWBRIDGE TOWN COUNCIL |

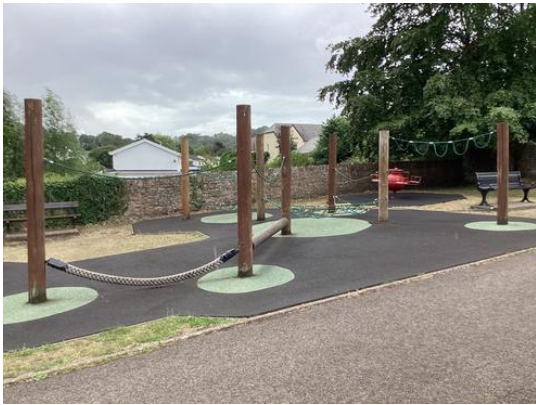
Photo 1

One of the platforms on the Sutcliffe play unit is showing signs of wear, while this is not currently a safety issue, the platform should be monitored for any further deterioration

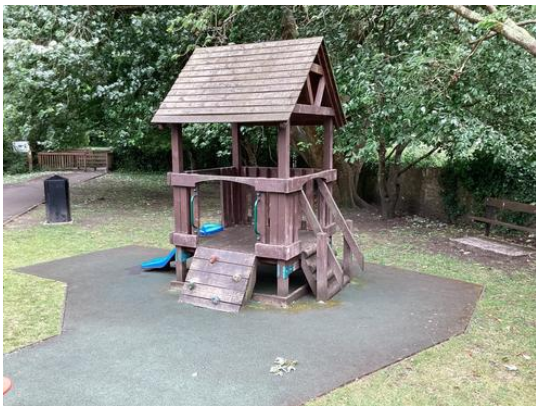
Photo 3

The steps and platform on the Landscape Structures unit and showing signs of wear around the

edges which should be monitored for further deterioration

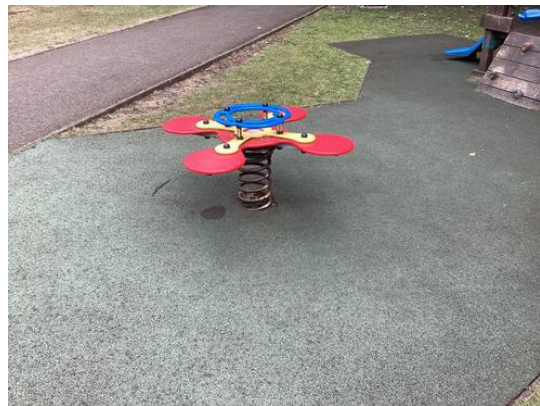
Photo 4

The 4 way spring rocker spring is loose on the ground fixing and should be secured to prevent further damage

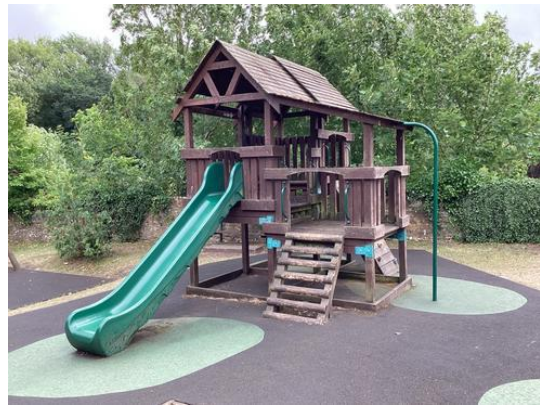
Photo 6

There are some roof slats loose or missing on the Sovereign timber multi play unit

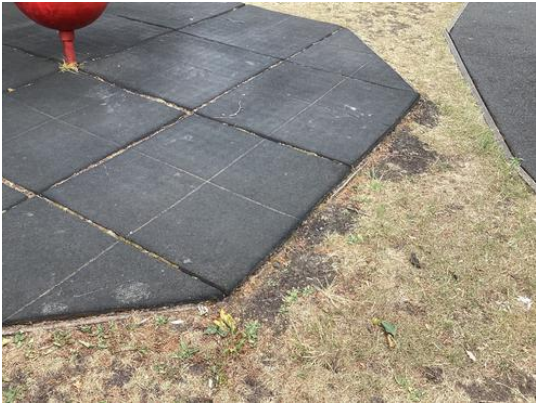
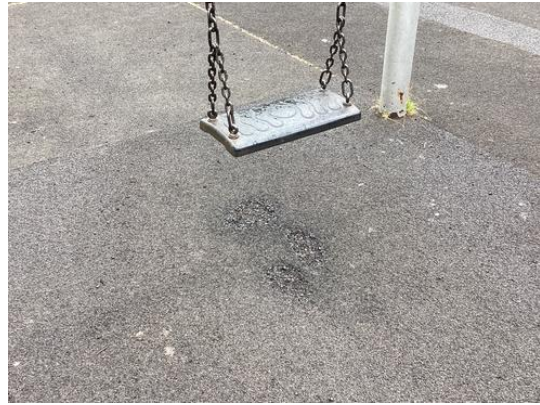
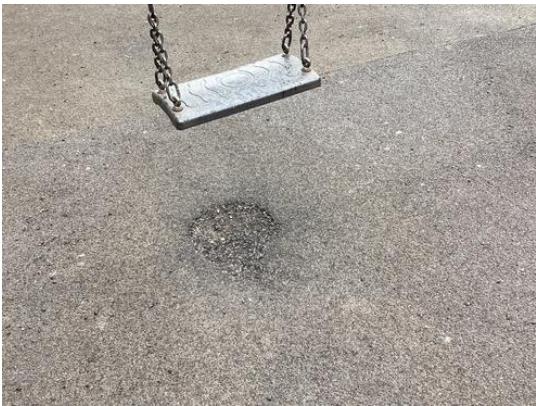
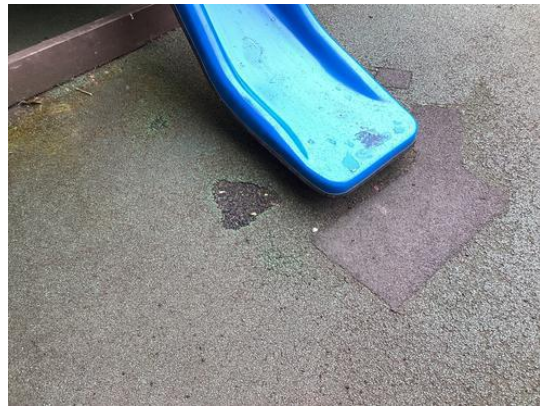
There are some surface areas under the flat seat swings, toddler slide that will need to be repaired.

The safety tiles around the Sputnik have a trip point

All items highlighted in the findings are low risk but some may need to be considered for repair sooner rather than later to prevent further deterioration
