## **Leisure & Amenities Report**

# Play Area / Equipment Operational Inspection

LLANBLETHIAN PARK PLAY AREA

TWT PARK PLAY AREA

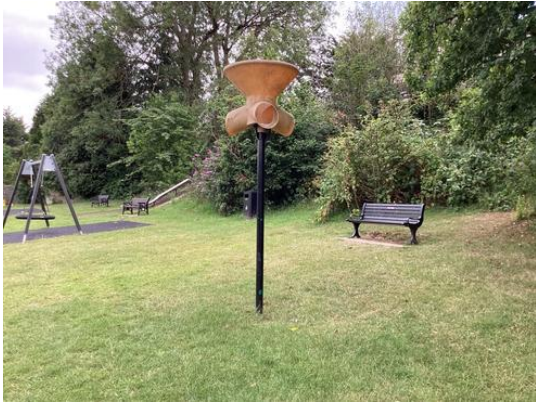
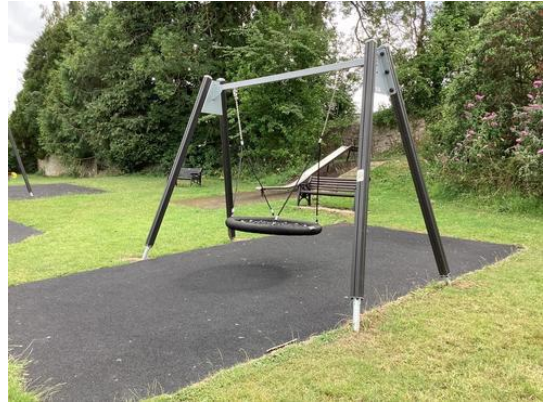
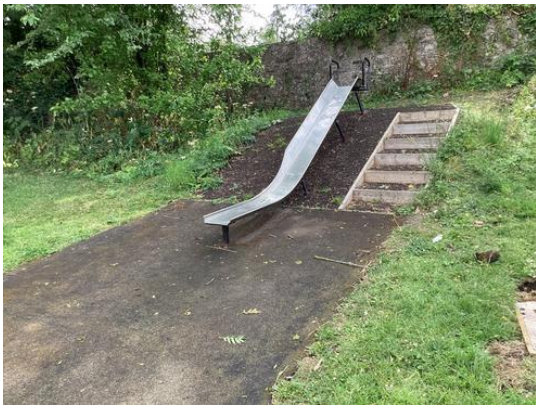
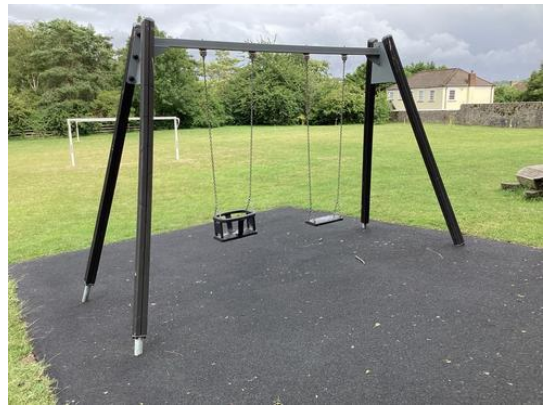
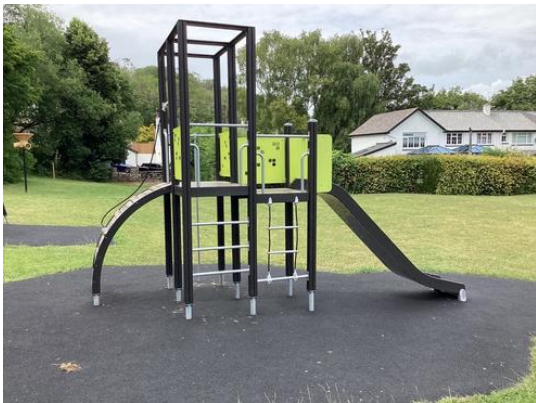
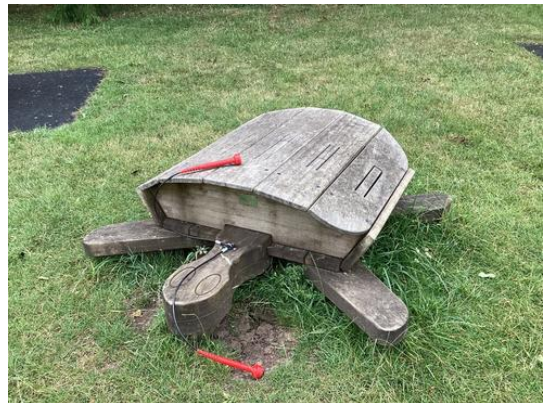
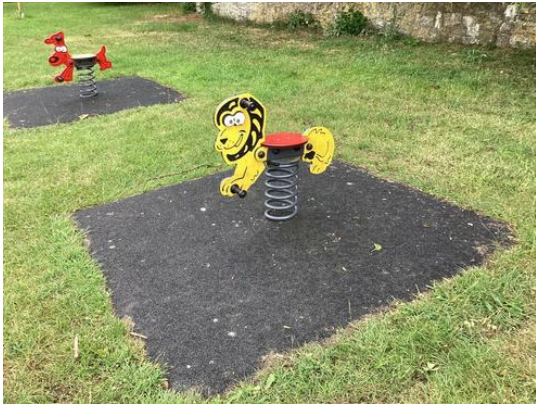
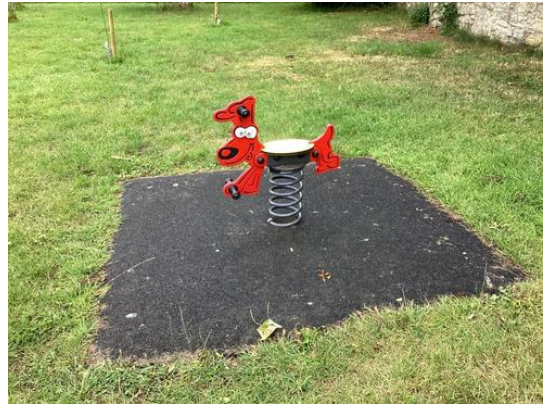
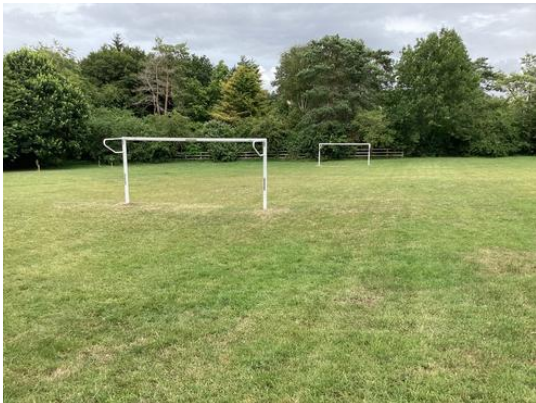
Llanblethian Play Area is an open playing field in a quiet area of the town, the play area is accessed across grass from the access gates located on the road.

The play equipment has been installed within the past few years and is all in very good condition and installed onto rubber safety surfacing

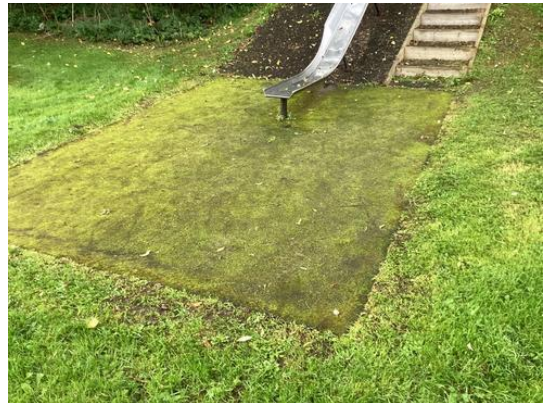
Photo 10

Surface at the bottom of the bank slide has a lot of moss growth and was quite slippery at the time of inspection which was done in damp conditions

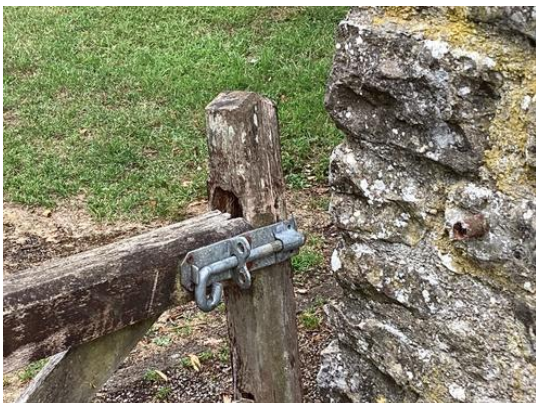
Photo 11

The access gates are showing signs of advanced rot which is preventing proper opening and closing

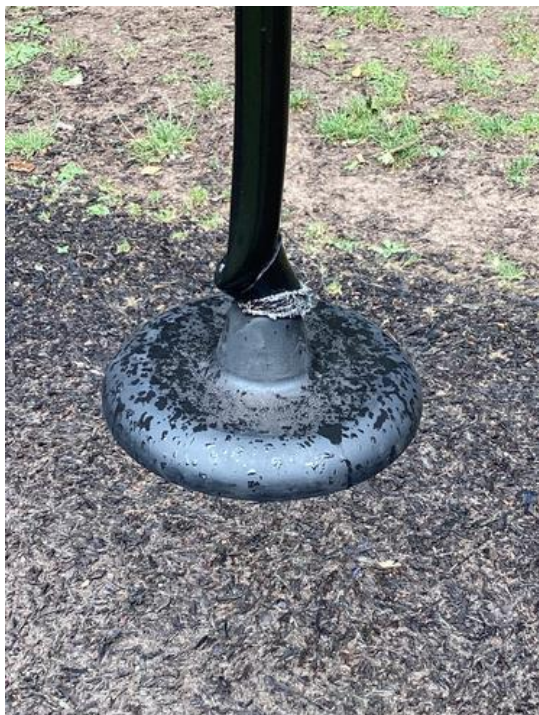
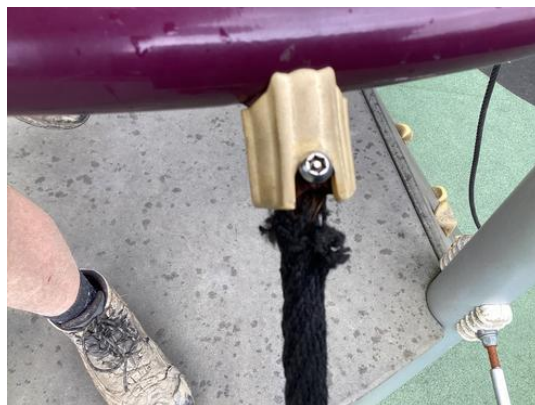
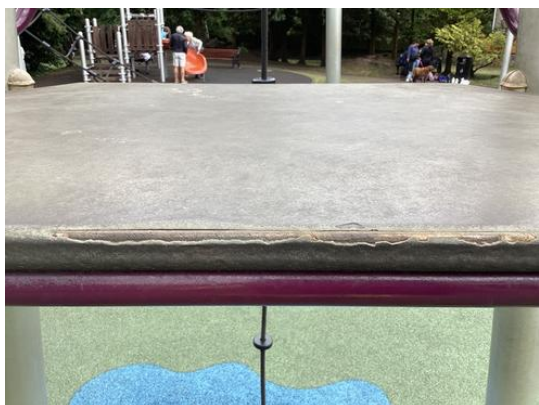
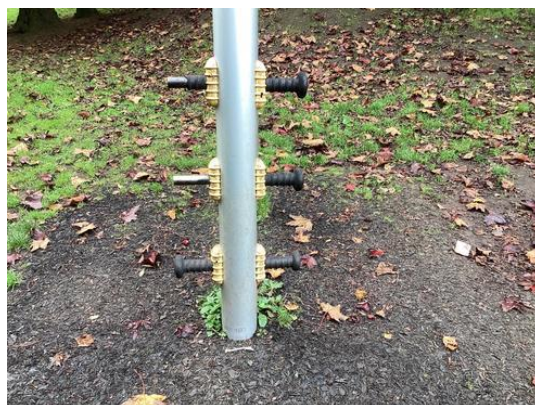
One of the platforms on the Sutcliffe play unit is showing signs of wear, while this is not currently a safety issue, the platform should be monitored for any further deterioration. On the same unit one of the climbing ropes is starting to show some wear on the top fixing and replacement should be considered in the near future.

The pendulum seat has a rubber sleeve covering the chain which has slipped down and replacement should be planned for at some point in the near future.

Two of the rubber footholds has been removed from the cable ride starting platform

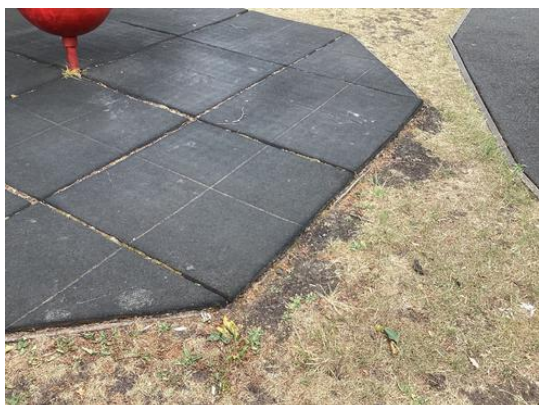
Photo 17

The safety tiles around the Sputnik have a trip point

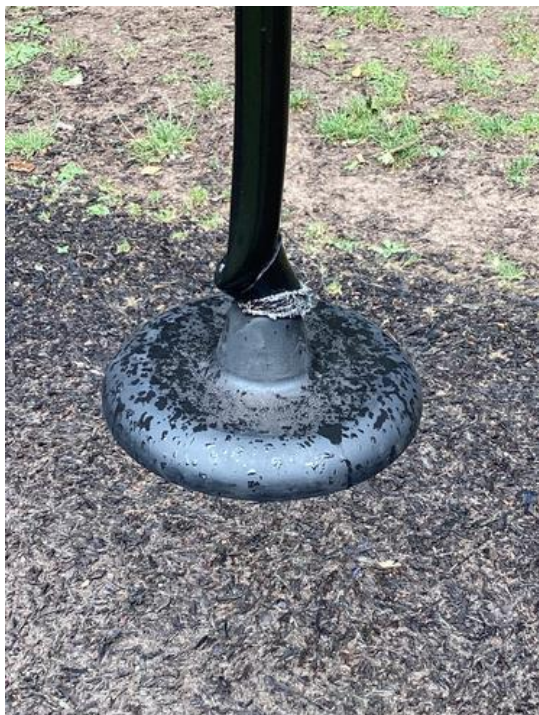
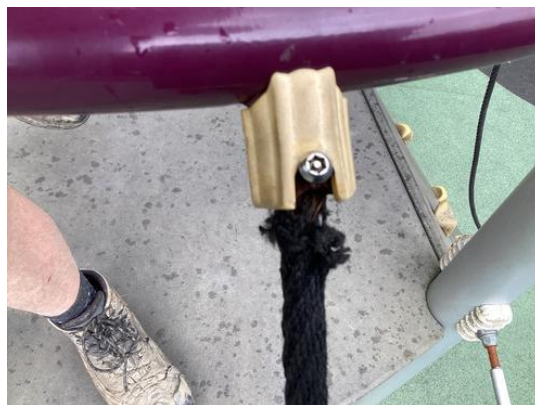
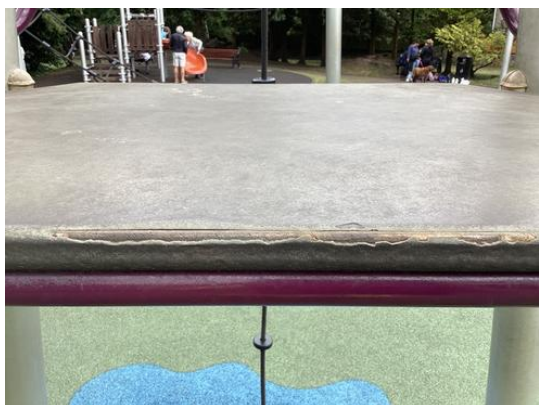
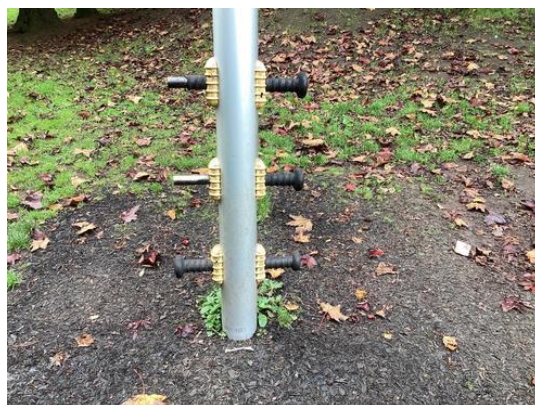
One of the platforms on the Sutcliffe play unit is showing signs of wear, while this is not currently a safety issue, the platform should be monitored for any further deterioration. On the same unit one of the climbing ropes is starting to show some wear on the top fixing and replacement should be considered in the near future.

The pendulum seat has a rubber sleeve covering the chain which has slipped down and replacement should be planned for at some point in the near future.

Two of the rubber footholds has been removed from the cable ride starting platform

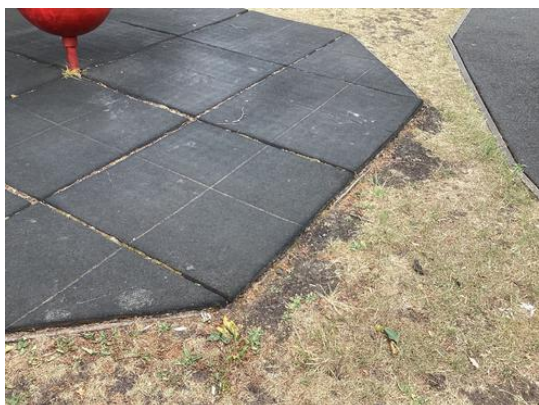
Photo 17

The safety tiles around the Sputnik have a trip point

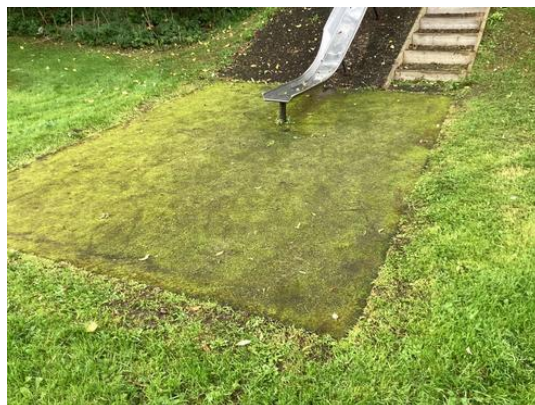
Photo 10

Surface at the bottom of the bank slide has a lot of moss growth and was quite slippery at the time of inspection which was done in damp conditions

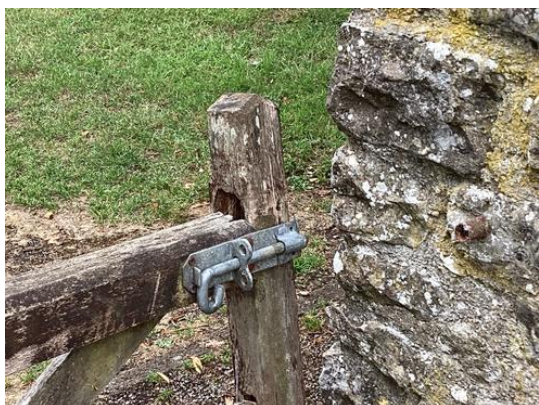
Photo 11

The access gates are showing signs of advanced rot which is preventing proper opening and closing
