# Play Area / Equipment Operational Inspection

TWT PARK PLAY AREA

| Client / Site | COWBRIDGE TOWN COUNCIL | | | | |
| Conducted on | 04.04.2024 08:01 BST | | | | |

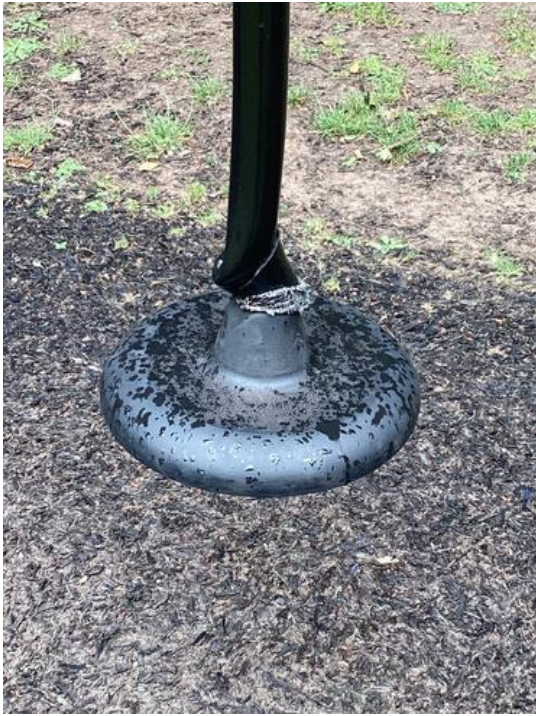
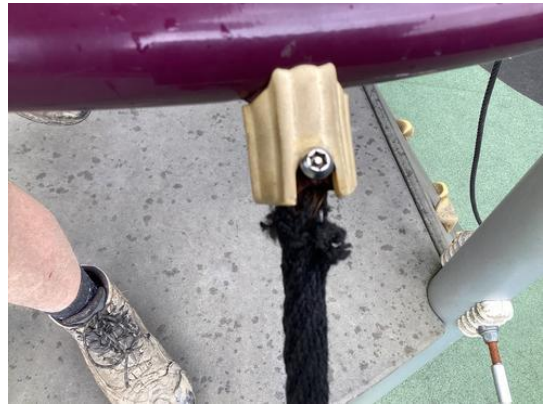
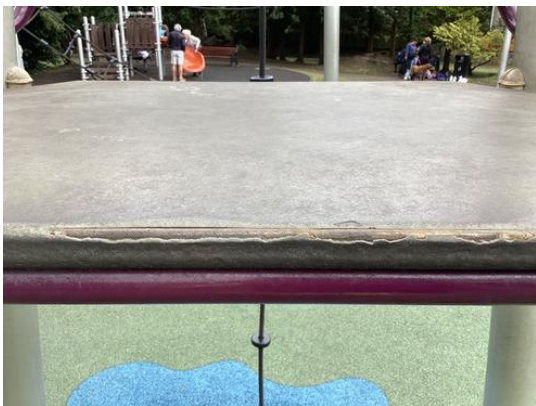
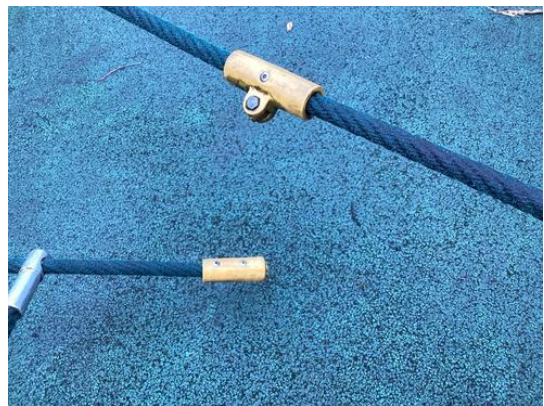
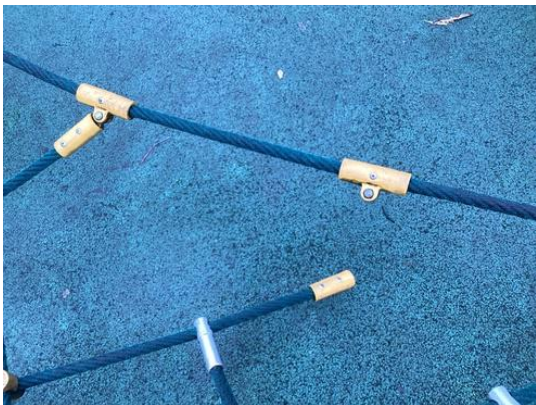
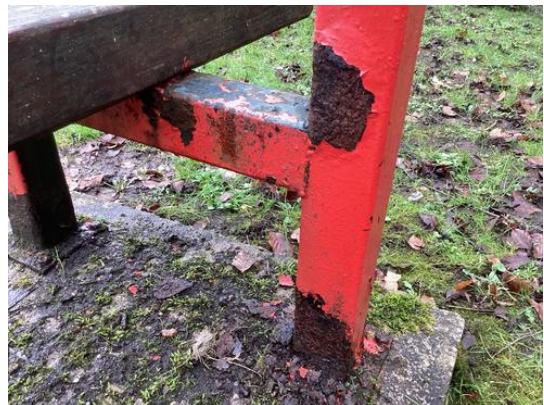
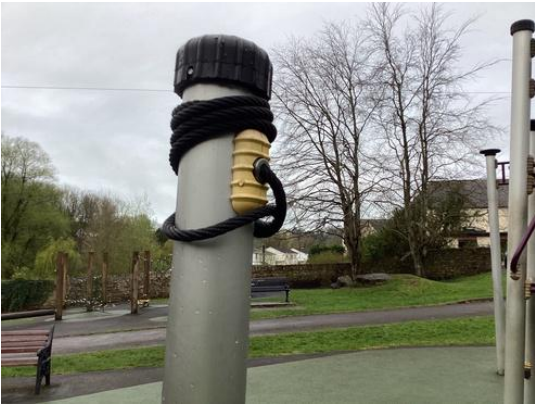
One of the platforms on the Sutcliffe play unit is showing signs of wear, while this is not currently a safety issue, the platform should be monitored for any further deterioration

On the same unit one of the climbing ropes is starting to show some wear on the top fixing and replacement should be considered in the near future

The pendulum seat has a rubber sleeve covering the chain which has slipped down and replacement should be planned for at some point in the near future.

Two of the rubber footholds have been replaced

One plastic rope fitting has broken on the adventure trail; replace (on order)

Heavy corrosion on the bench frames by cradle swing

Climbing rope has snapped, replace (on order)

Change broken plastic rope fitting

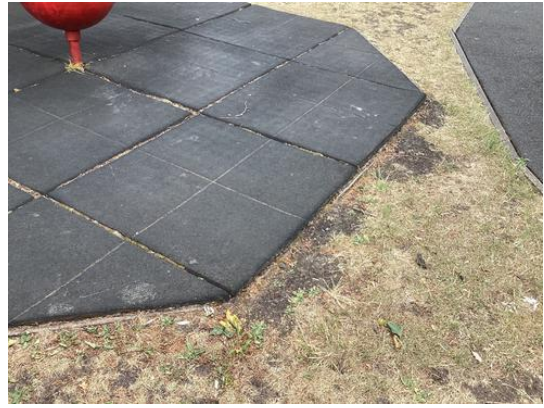
Photo 22

The safety tiles around the Sputnik have a trip point
