# Play Area / Equipment Operational Inspection

TWT PARK PLAY AREA

| Client / Site | COWBRIDGE TOWN COUNCIL | | | | |
| Conducted on | 09.08.2024 20:30 BST | | | | |

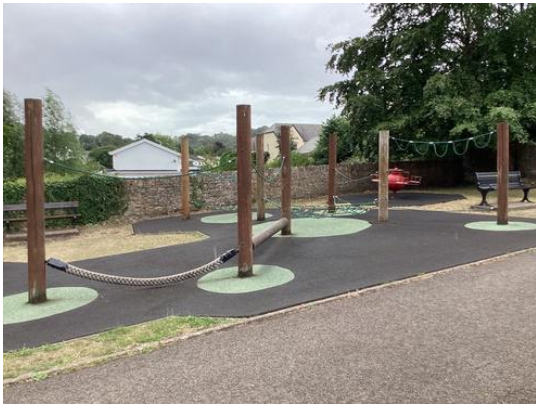
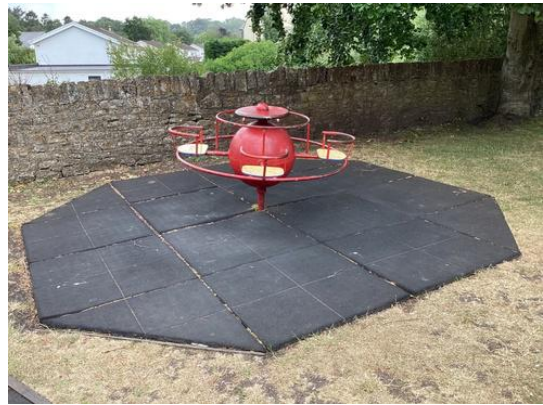
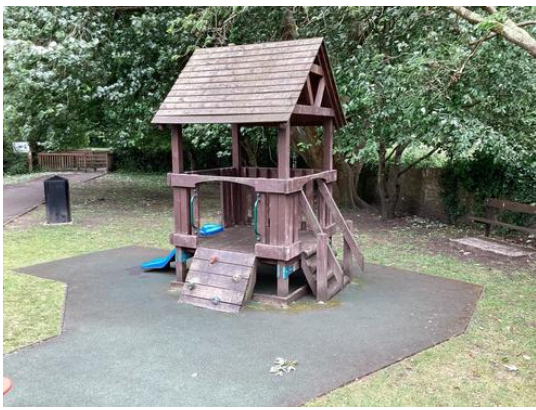
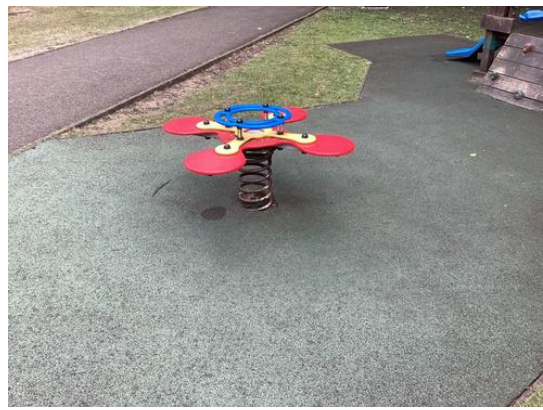
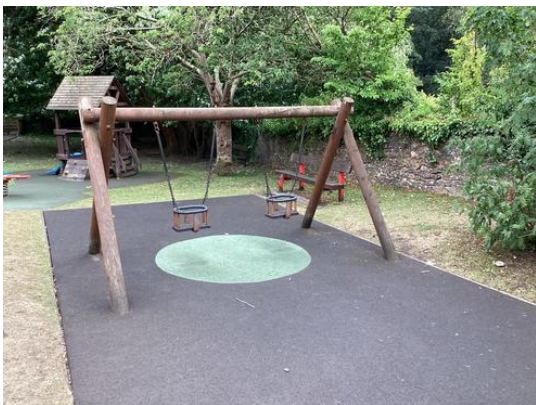
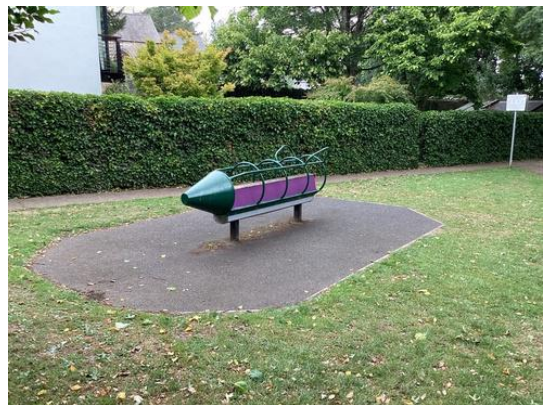
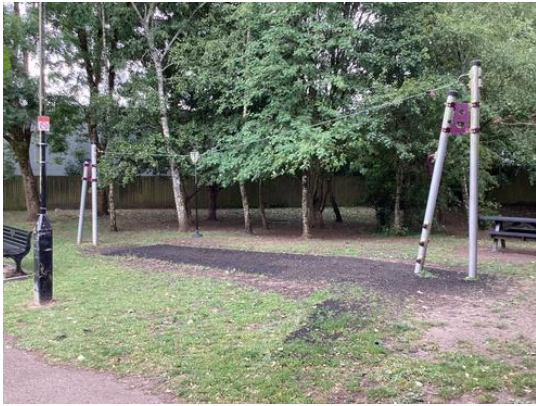
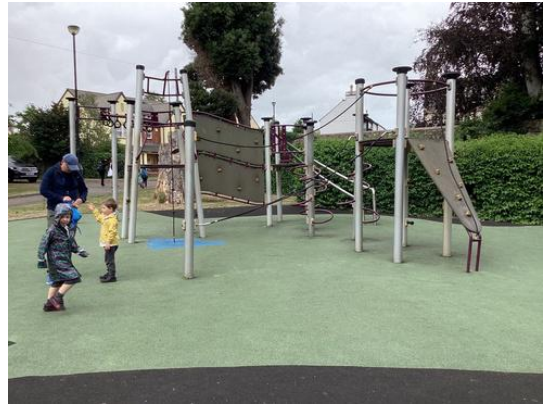
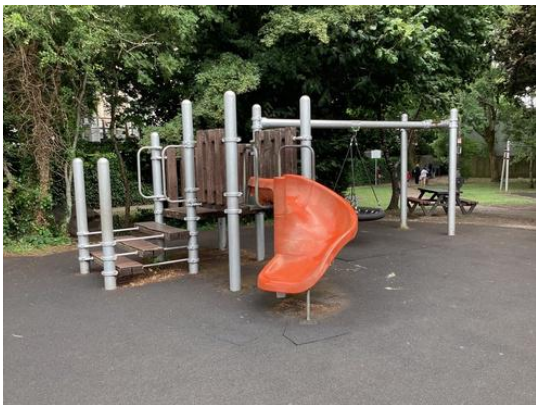
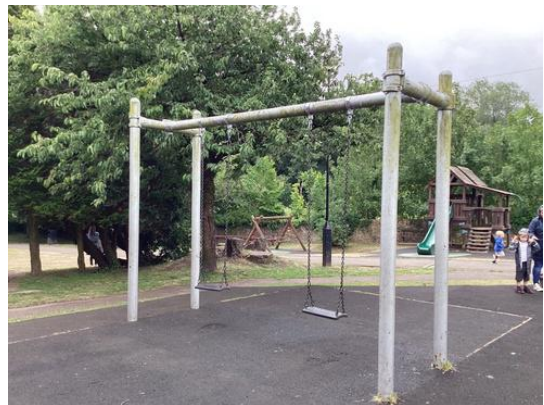
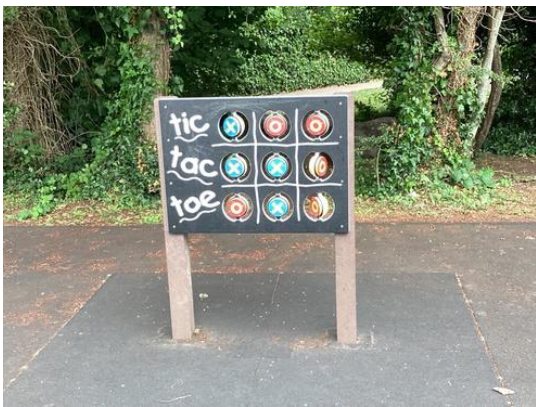
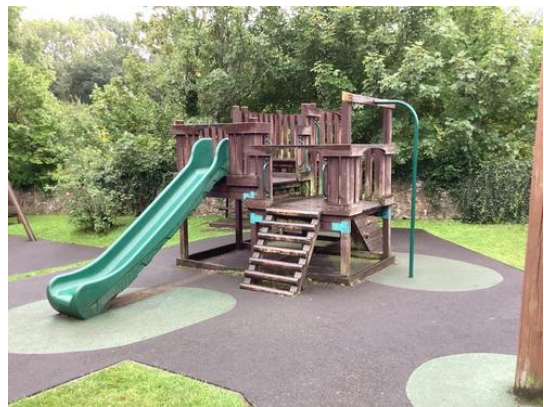
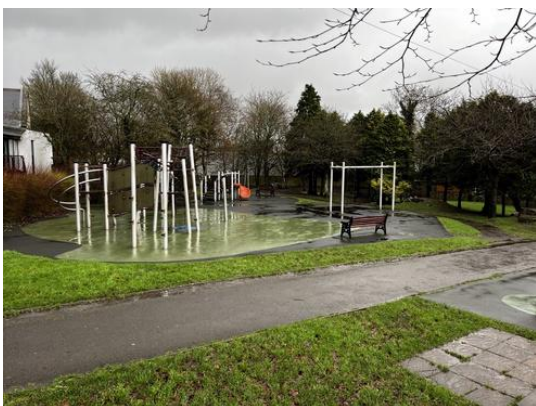
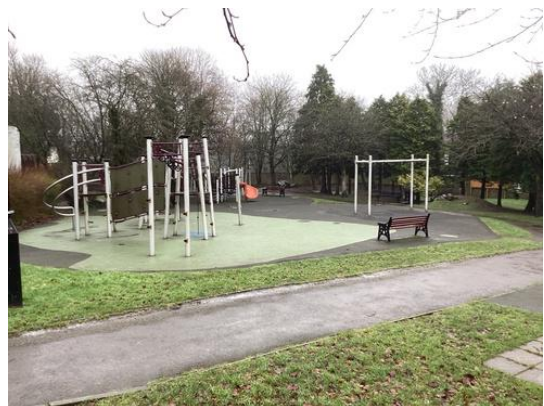
Twt Park Play Area is a walkthrough park with easy access from 3 directions from different parts of the town. All pathways and different zones of the play area are easily accessible. Due to the nature of the park the play area is not fenced. The play equipment is separated into different zones and all play equipment is installed onto rubber safety surfacing.

Sutcliffe Multi play unit installation date unknown  
 Sutcliffe cable ride installation date unknown  
 Wicksteed rocket rocker installation date unknown  
 Landscape structures play unit and swing installation date late eighties  
 Urban Recreation play panel installation date 2018  
 Sovereign play multi units and challenge walk installation date unknown  
 Wicksteed Sputnik roundabout installation date unknown  
 Sovereign Play toddler swing installation date unknown  
 Spring rocker installation date unknown

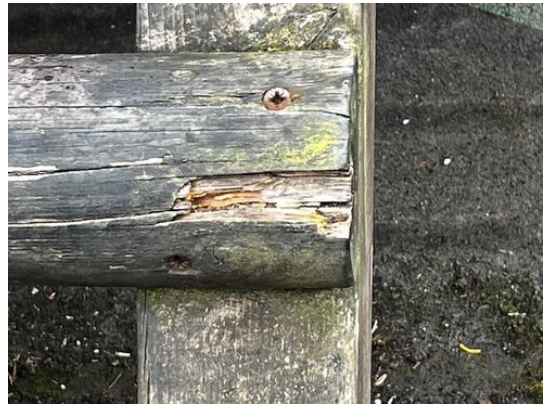
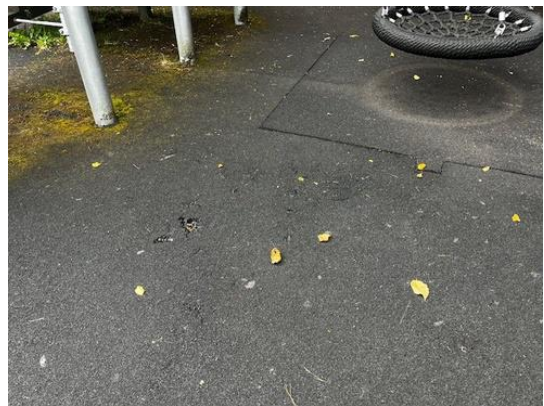
One of the platforms on the Sutcliffe play unit is showing signs of wear, while this is not currently a safety issue, the platform should be monitored for any further deterioration

The pendulum seat has a rubber sleeve covering the chain which has slipped down and replacement should be planned for at some point in the near future.

One plastic rope fitting has now been replaced

Heavy corrosion on the bench frames by cradle swing

Some evidence of timber decay on timber ladder, monitor

Sheared bolt on swings has been replaced

Areas of rubber safety surfacing have some wear and could benefit from patching

Patch rubber mulch under cable ride and replace cover tube on cable ride swing
