# Play Area / Equipment Operational Inspection

TWT PARK PLAY AREA

| Client / Site | COWBRIDGE TOWN COUNCIL | | | | |
| Conducted on | 15.07.2024 15:30 BST | | | | |

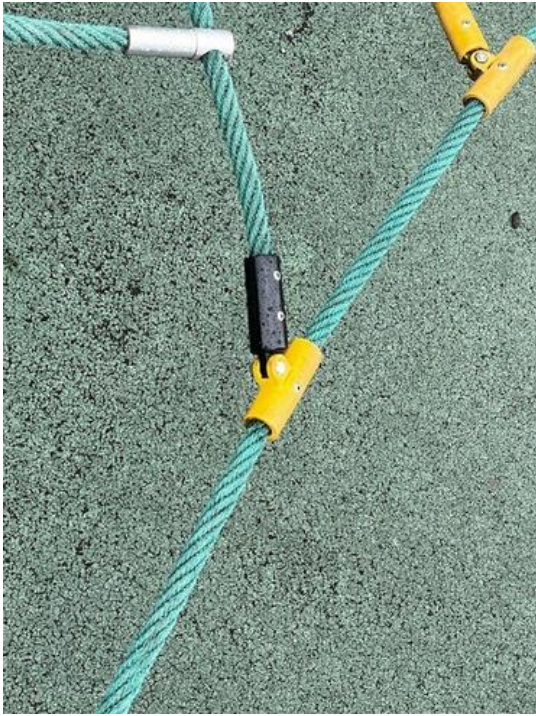
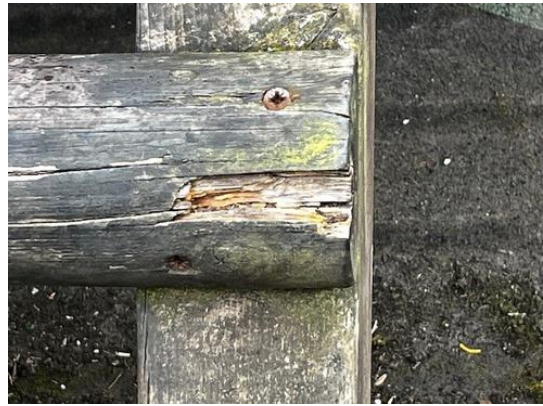
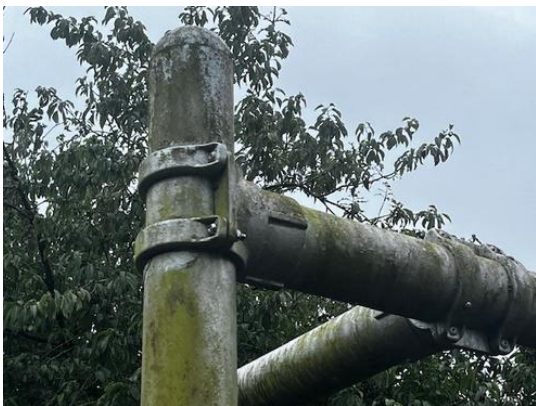
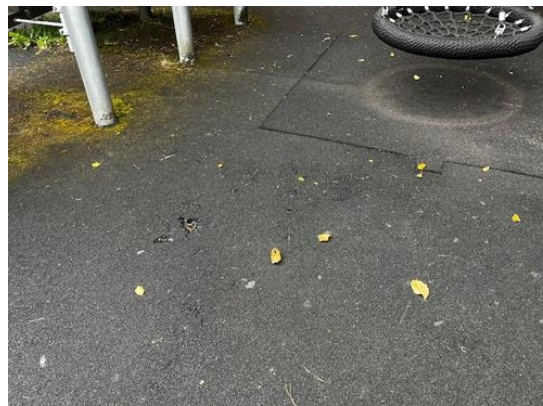
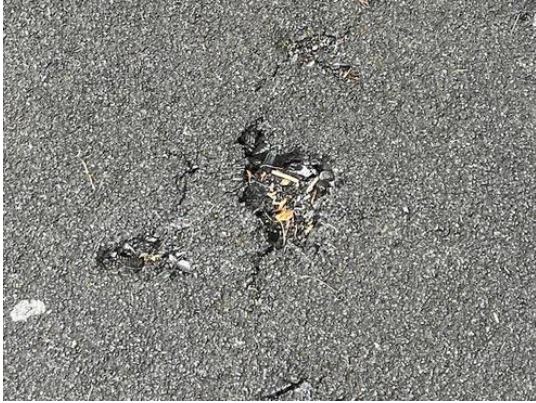
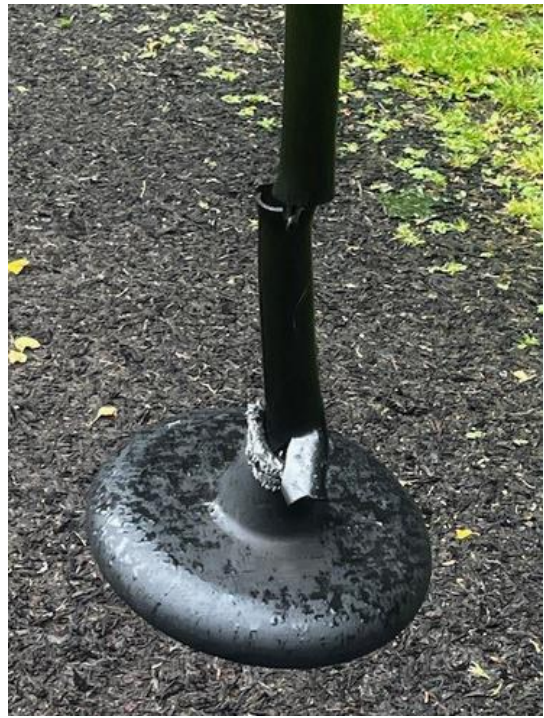
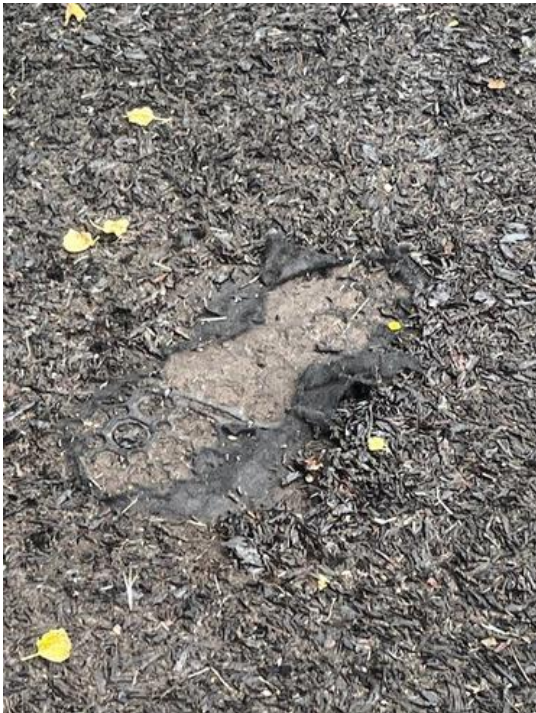
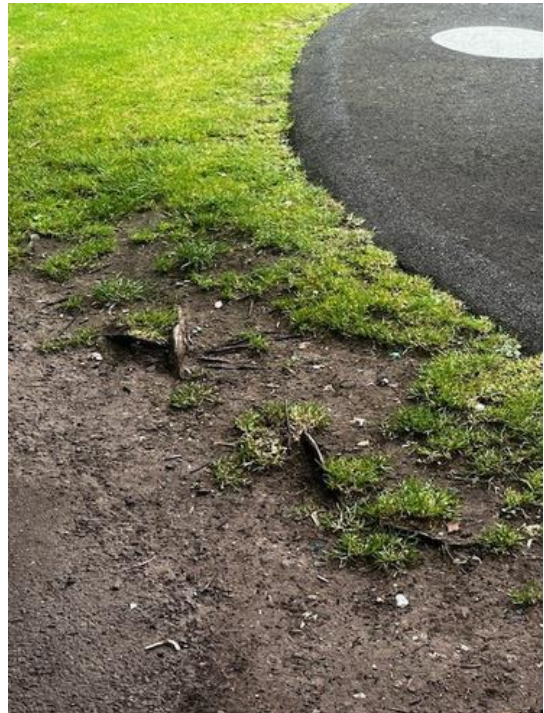
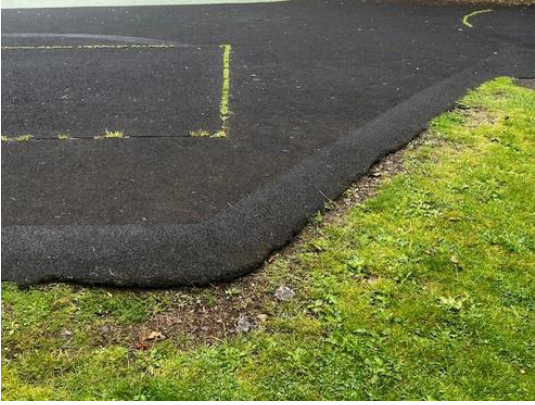
One of the platforms on the Sutcliffe play unit is showing signs of wear, while this is not currently a safety issue, the platform should be monitored for any further deterioration

The pendulum seat has a rubber sleeve covering the chain which has slipped down and replacement should be planned for at some point in the near future.

One plastic rope fitting has now been replaced

Heavy corrosion on the bench frames by cradle swing

Some evidence of timber decay on timber ladder, monitor

Sheared bolt on swings has been replaced

Areas of rubber safety surfacing have some wear and could benefit from patching

Patch rubber mulch under cable ride and replace cover tube on cable ride swing

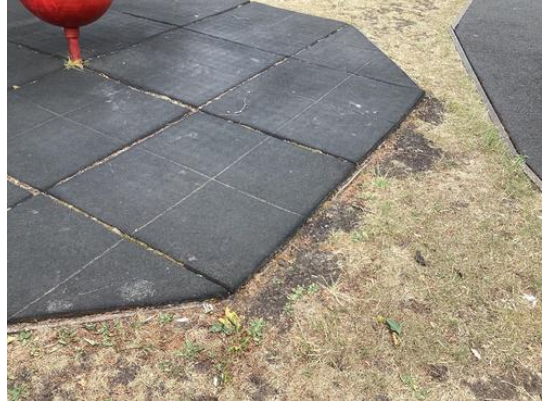
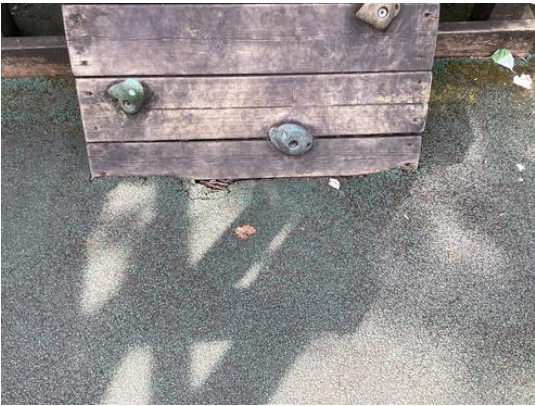
The safety tiles around the Sputnik have a trip point

Surface at bottom of timber ramp on toddler unit may need patching in the near future, monitor
