# Play Area / Equipment Operational Inspection

TWT PARK PLAY AREA

| Client / Site | COWBRIDGE TOWN COUNCIL | | | | |
| Conducted on | 04.06.2024 23:00 BST | | | | |

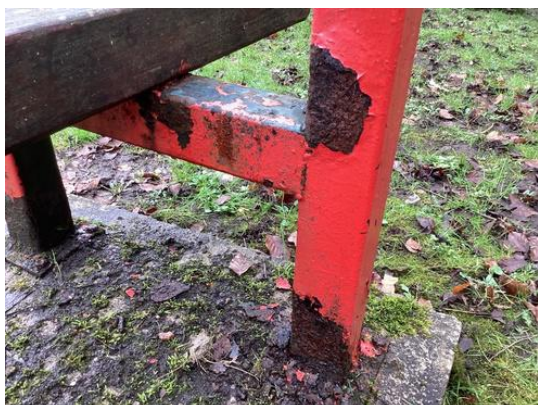
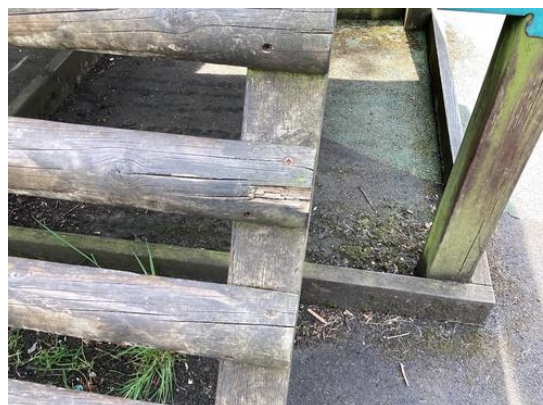
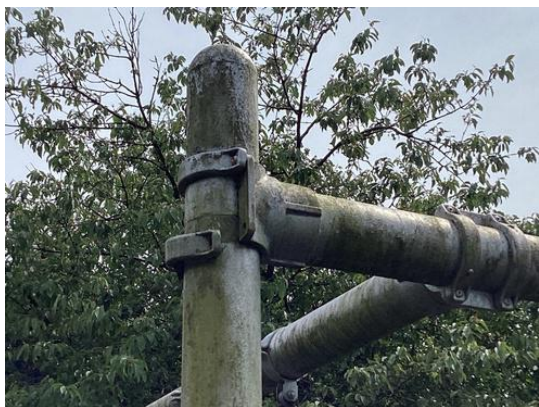
One of the platforms on the Sutcliffe play unit is showing signs of wear, while this is not currently a safety issue, the platform should be monitored for any further deterioration

The pendulum seat has a rubber sleeve covering the chain which has slipped down and replacement should be planned for at some point in the near future.

One plastic rope fitting has broken on the adventure trail; replace (on order)

Heavy corrosion on the bench frames by cradle swing

Some evidence of timber decay on timber ladder, monitor

Sheared bolt on swings has been replaced

Change broken plastic rope fitting
