# Play Area / Equipment Operational Inspection

TWT PARK PLAY AREA

| Client / Site | COWBRIDGE TOWN COUNCIL | | | | |
| Conducted on | 31.10.2025 07:30 GMT | | | | |

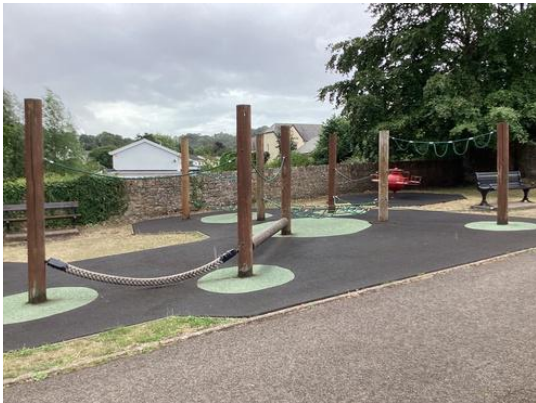
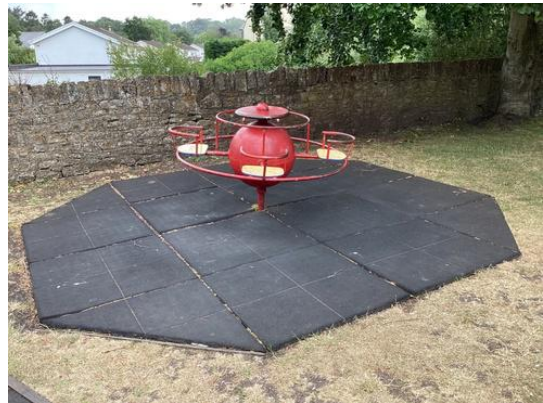
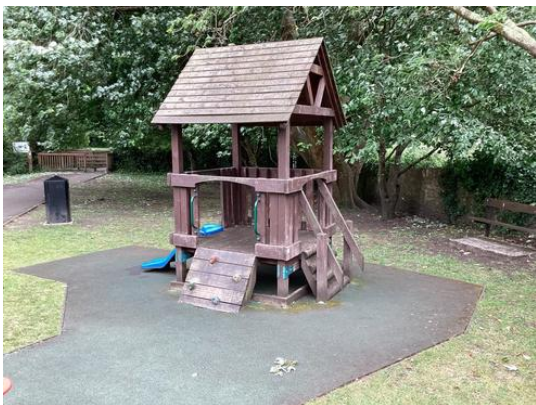
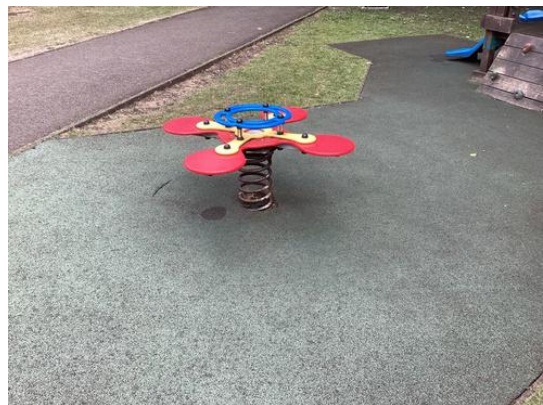
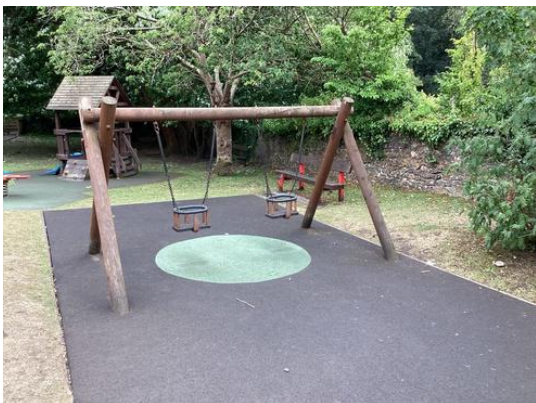
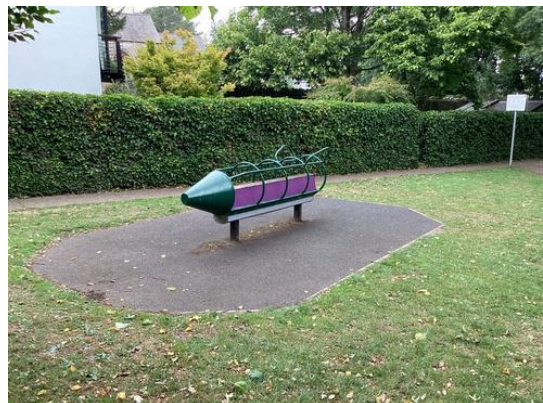
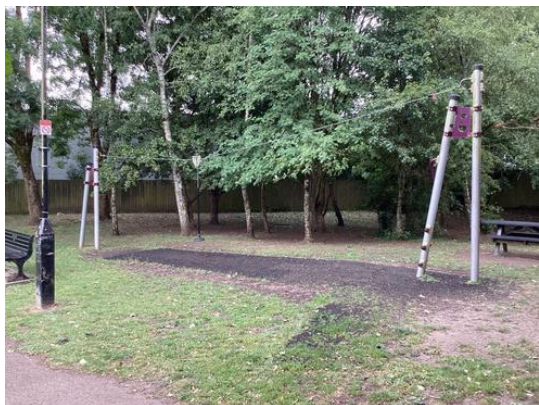
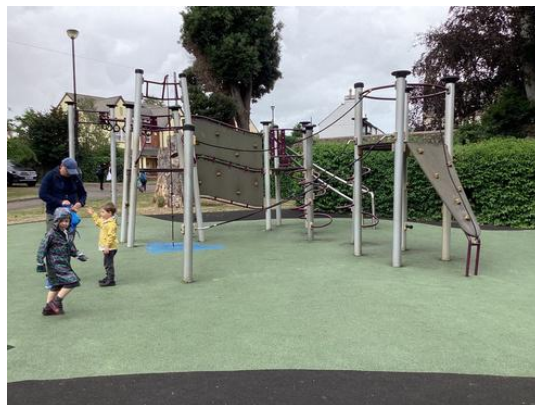
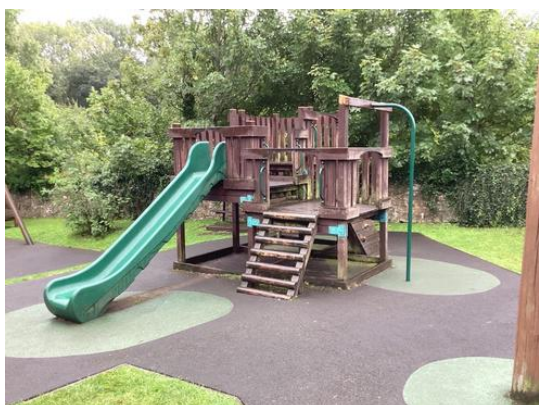
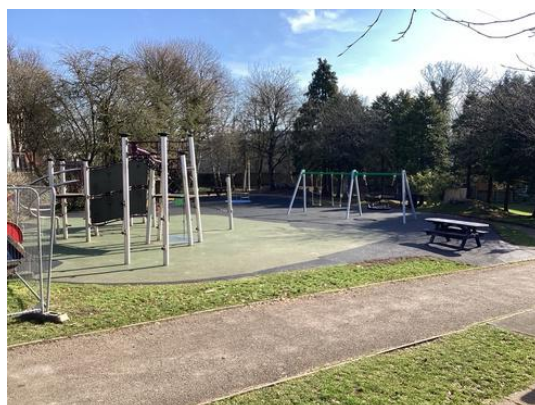
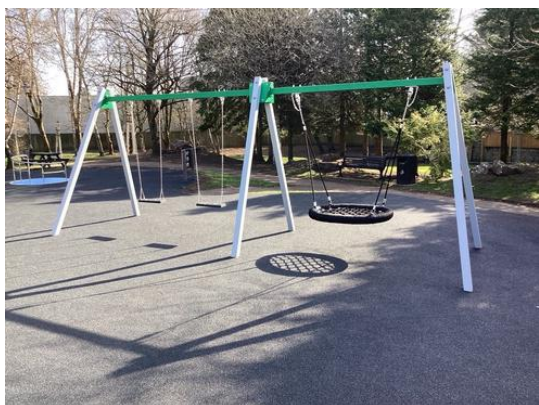
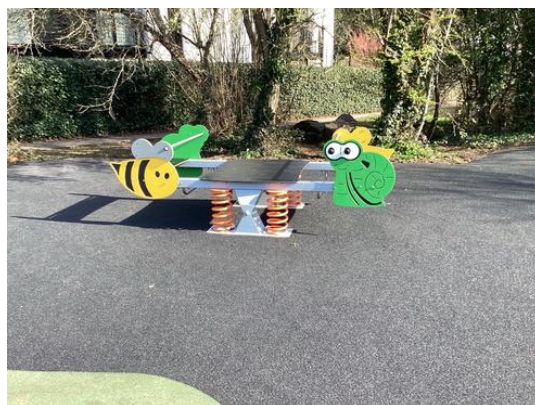
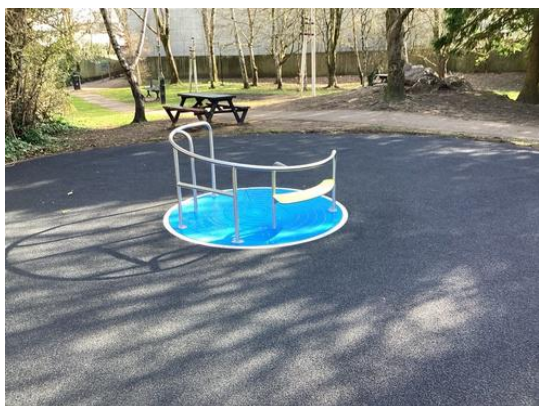
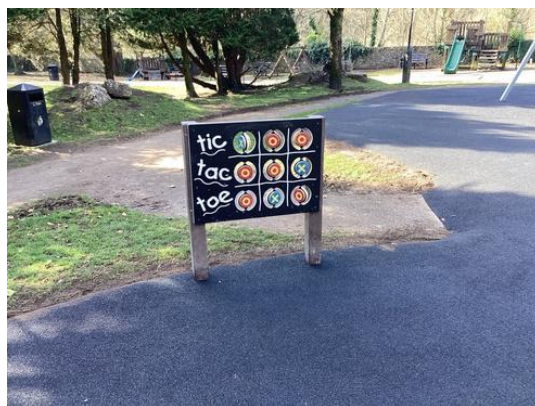
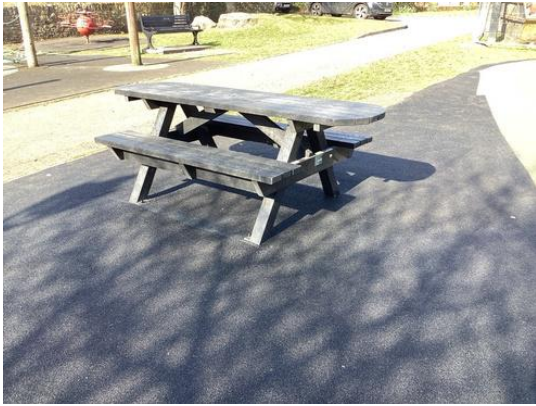
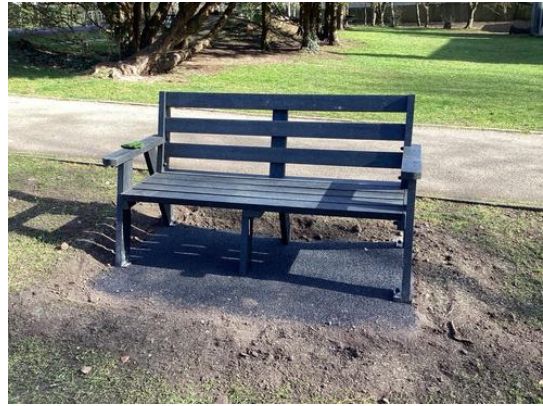
Twt Park Play Area is a walkthrough park with easy access from 3 directions from different parts of the town. All pathways and different zones of the play area are easily accessible. Due to the nature of the park the play area is not fenced. The play equipment is separated into different zones and all play equipment is installed onto rubber safety surfacing.

Sutcliffe Multi play unit installation date unknown  
 Sutcliffe cable ride installation date unknown  
 Wicksteed rocket rocker installation date unknown  
 Urban Recreation play panel installation date 2018  
 Sovereign play multi units and challenge walk installation date unknown  
 Wicksteed Sputnik roundabout installation date unknown  
 Sovereign Play toddler swing installation date unknown  
 Vinci Play swing installed March 2025  
 Vinci Play double seesaw installed March 2025  
 Vinci Play roundabout installed March 2025

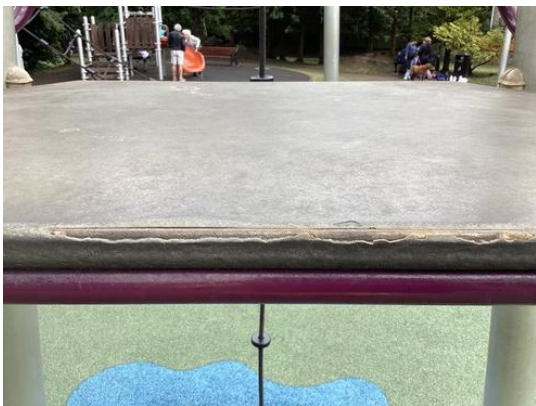
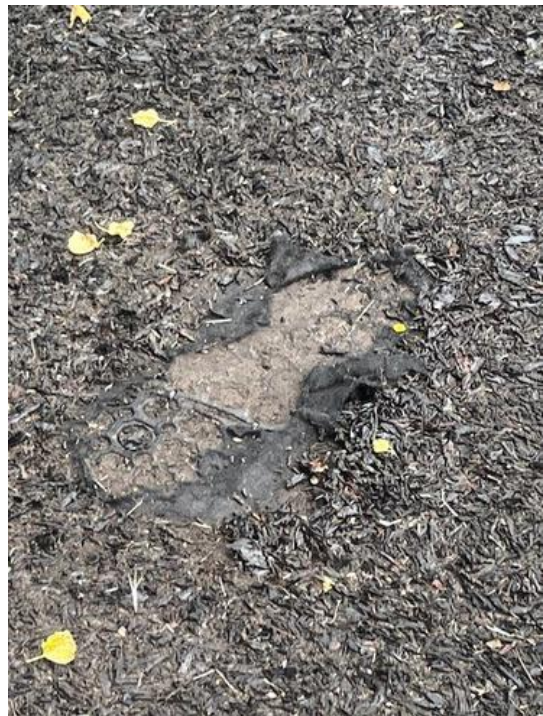
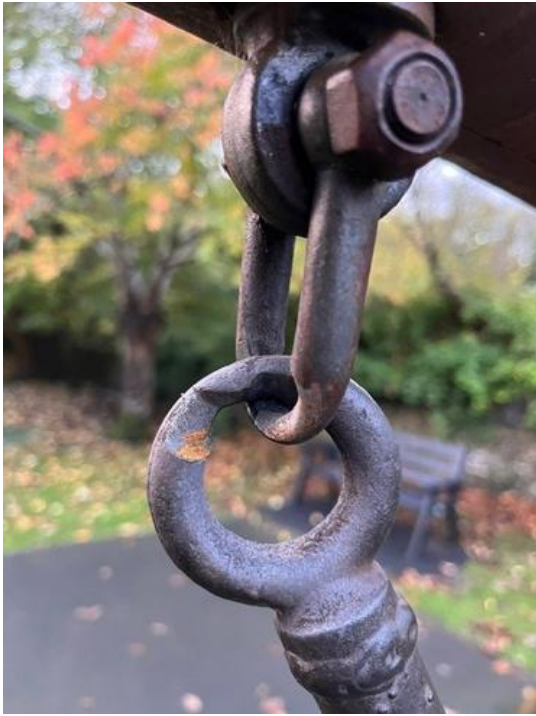
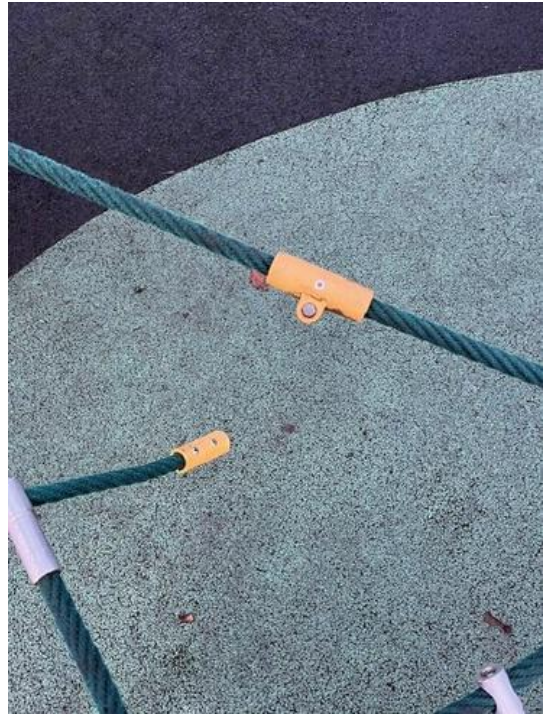
One of the platforms on the Sutcliffe play unit is showing signs of wear, while this is not currently a safety

issue, the platform should be monitored for any further wear.  
Climbing net fixing has become detached, new fitting has been ordered  
The top fixing on one of the cradle swing has badly worn and needs to be replaced

- Patch rubber mulch under cable ride
- Refer to contractor for surfacing repairs
- Replace broken fixing on net (part on order)
- Replace worn swing pivot on cradle swing

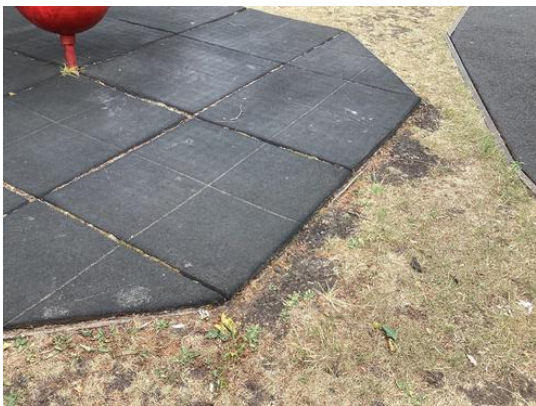
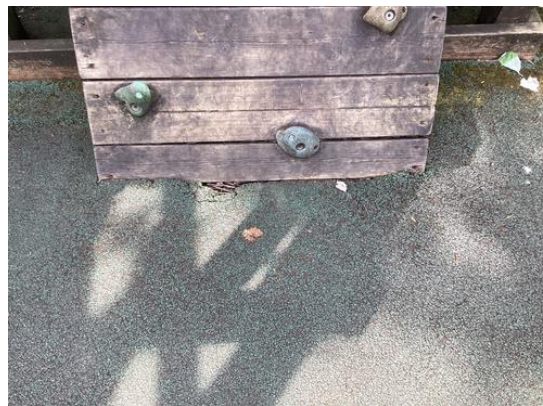
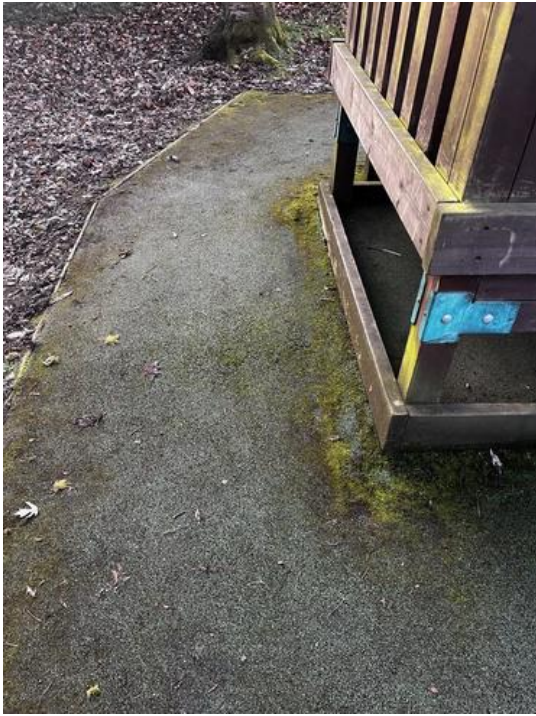
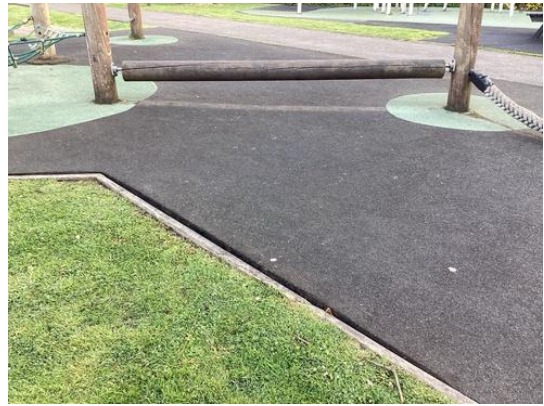
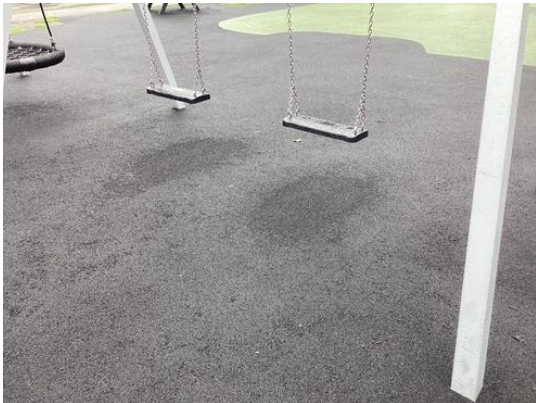
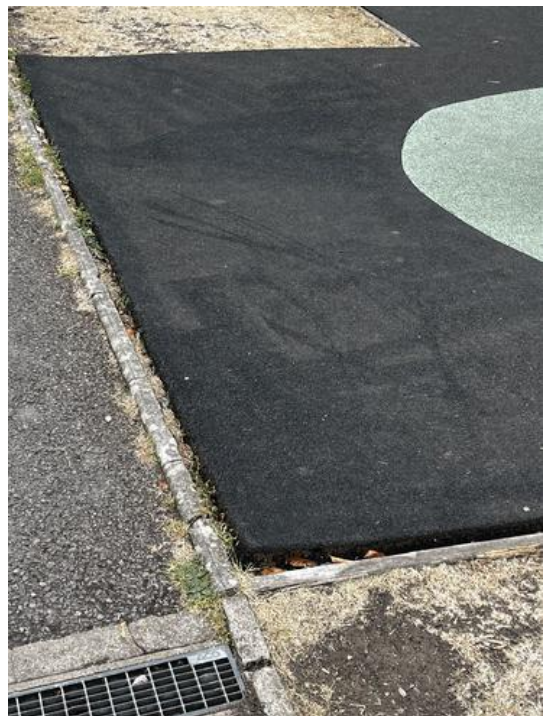
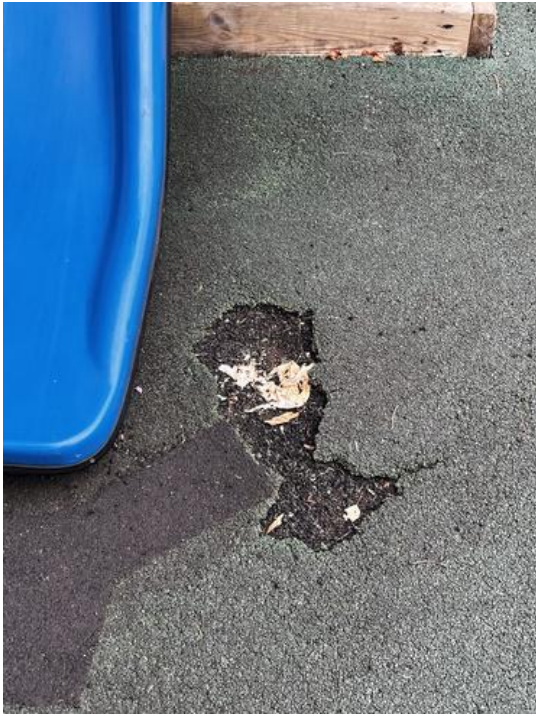
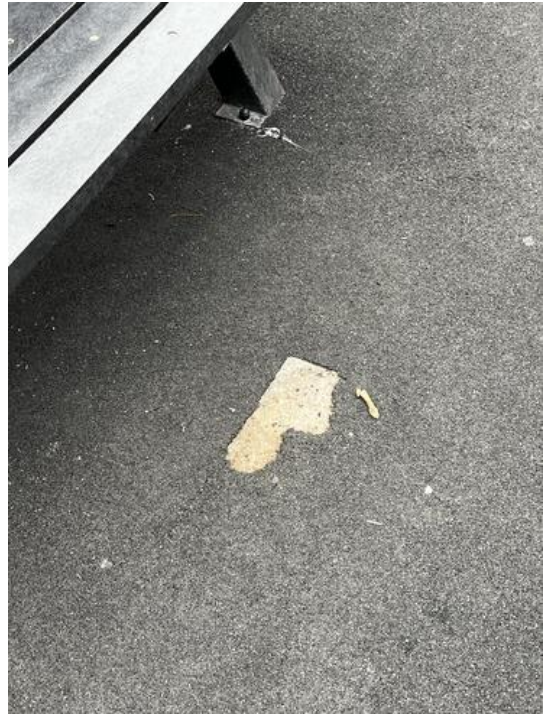
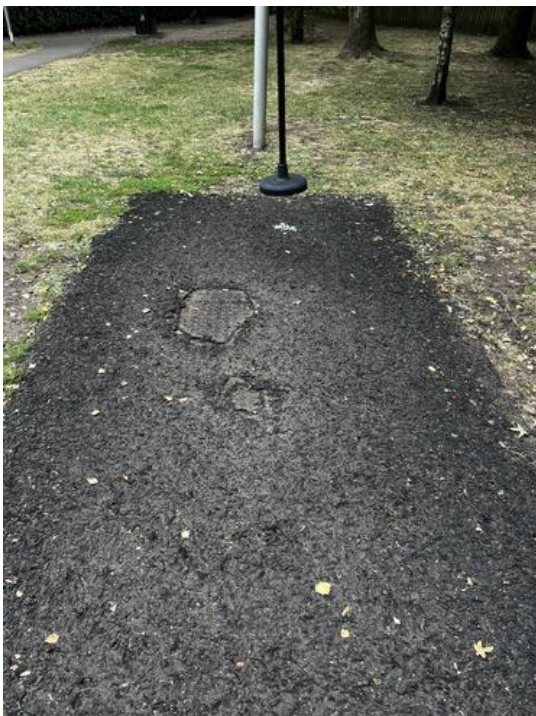
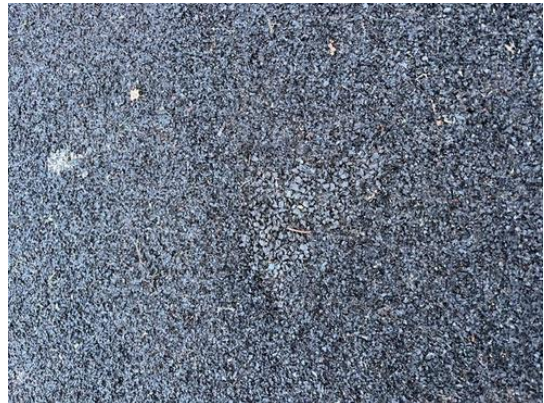
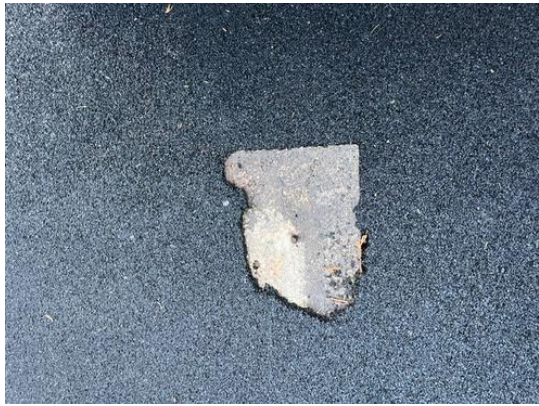
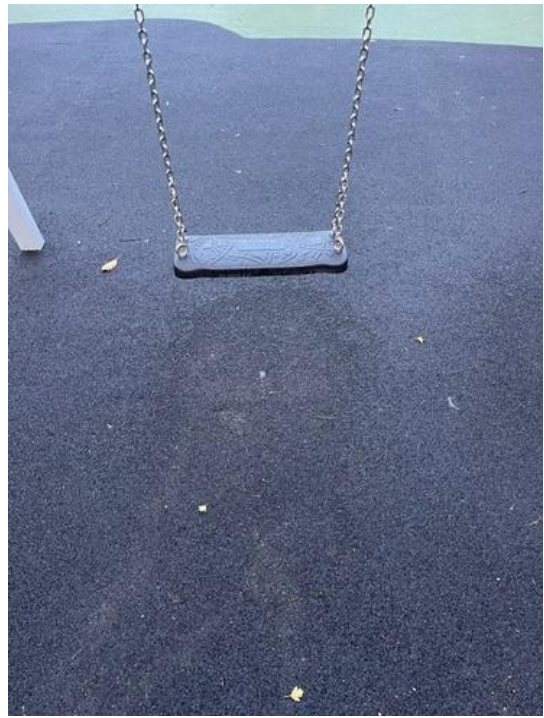
The safety tiles around the Sputnik have a trip point

Surface at bottom of timber ramp and slide on toddler unit may need patching in the near future, monitor

The new safety surfacing is starting to lift in the area near the picnic table, The thickness of the surfacing is only 5mm (15mm recommended) and is not adhered to the old concrete pad, this has increased slightly in size since last inspection Due to the recent laying of this i would suggest referring back to the contractor, The surfacing under the new swings is starting to show premature wear and in one small area is now through to the base rubber below  
The surfacing under the roundabout is starting to show premature wear and also has one small area that is showing the base rubber below
