# Play Area / Equipment Operational Inspection

TWT PARK PLAY AREA

| Client / Site | COWBRIDGE TOWN COUNCIL | | | | |
| Conducted on | 26.09.2024 09:40 BST | | | | |

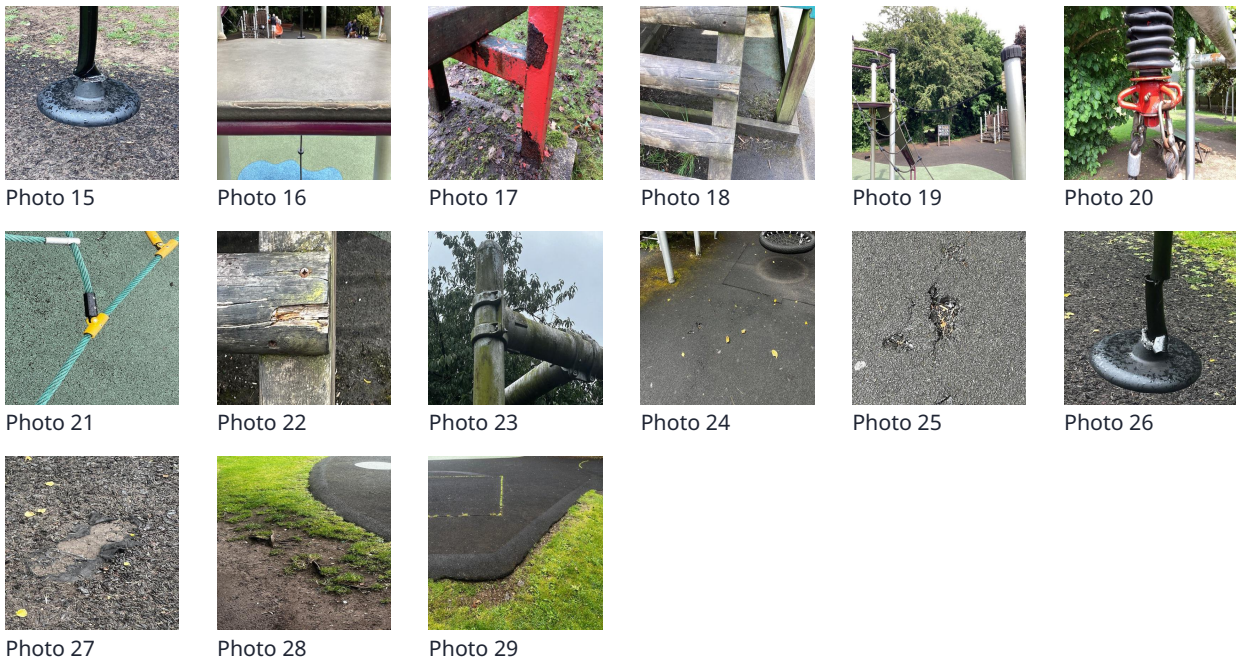
One of the platforms on the Sutcliffe play unit is showing signs of wear, while this is not currently a safety issue, the platform should be monitored for any further deterioration

The pendulum seat has a rubber sleeve covering the chain which has slipped down and replacement should be planned for at some point in the near future.

Heavy corrosion on the bench frames by cradle swing

Some evidence of timber decay on timber ladder, monitor

Areas of rubber safety surfacing have some wear and could benefit from patching

Patch rubber mulch under cable ride and replace cover tube on cable ride swing
